Chapter 11

Inventory & Assessments

Park Inventory and Assessments

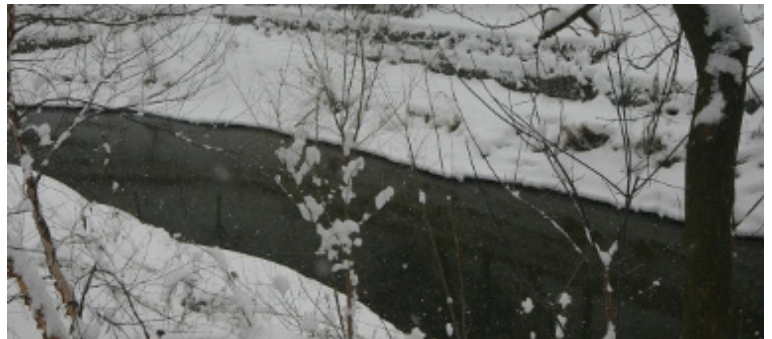
Running north-south, this slightly larger creek passes through residents' backyards and offers natural space, such as Lawler Park Greenspace, alongside other portions of its shoreline. Not only does Schoon Ditch feed into Hart Ditch, but so does Dyer Ditch, Schererville Ditch, Cady Marsh Ditch, and Plum Creek. These creeks drain a 90-square-mile area into the Little Calumet River.

Earlier this century, there were complaints about erosion of the Hart Ditch and the loss of property for the residents whose backyards were adjacent to the ditch. Structural damage was a concern for both sides of the ditch near Circle Park. Renovations along the creek's edge were constructed in the early 2000's as a way to prevent this from continuing.

As it approaches the river, flooding remains a general concern for the Hart Ditch, even with the construction of the flood levees. At the same time, there is a greater distance between homes and the Hart Ditch once it gets closer to the Little Calumet, slightly reducing risk of property damages. The open space, protected by high berms, eventually replaces the flood levee, providing potential for flood prevention by utilizing rain gardens and level spreaders.

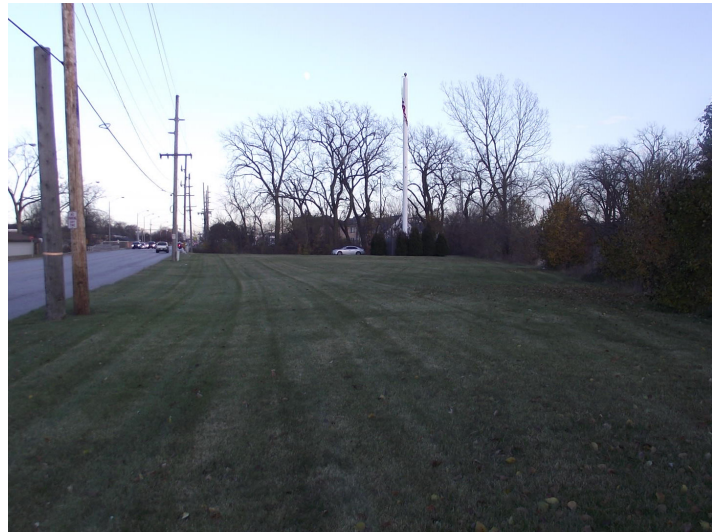
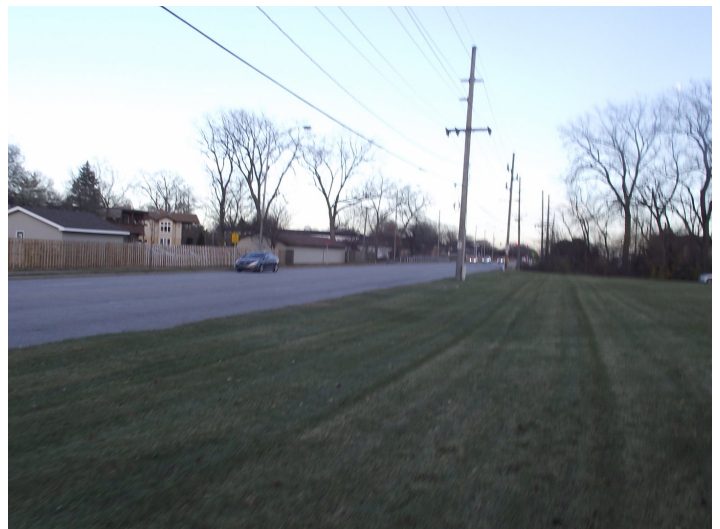
Figure 49: 45th Avenue Greenspace

Because this is a narrow property alongside a heavy traffic corridor, it has limited potential.

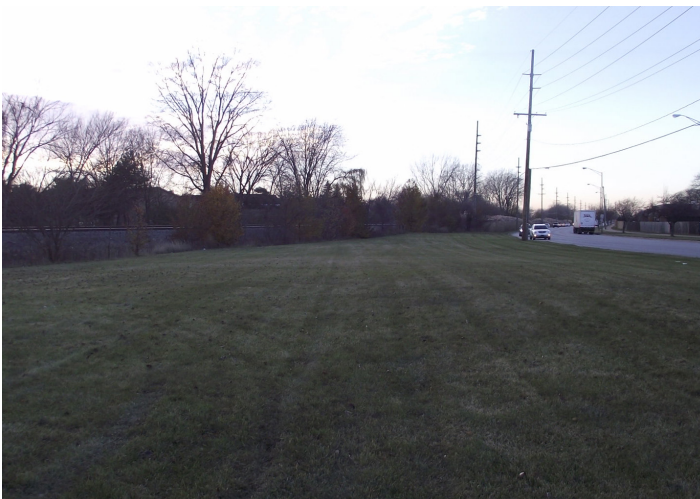
There is currently no pedestrian access to the space, and only a single lane vehicular drive leading to a utility box next to the flag pole. It is concealed, in part, by upright arborvitae bushes.

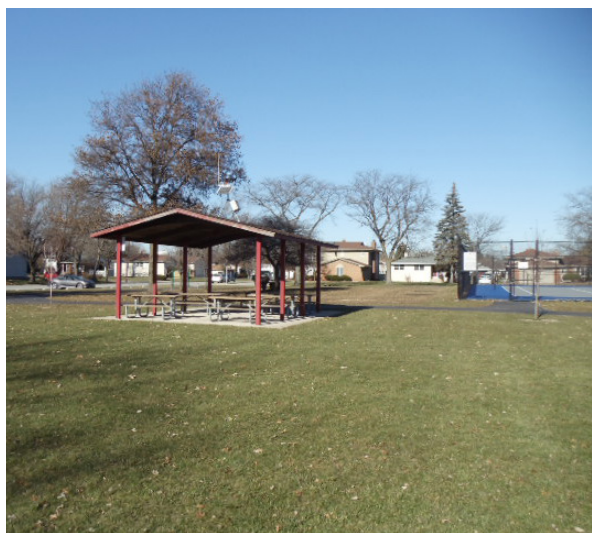
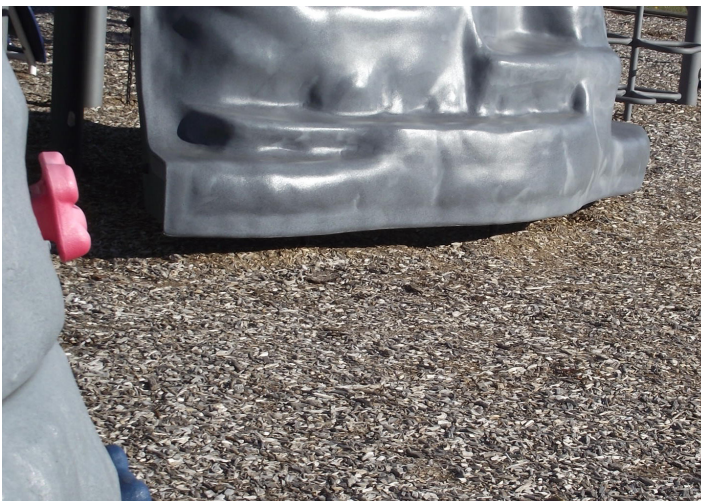
Figure 53: Briar Creek Park

The hard surfacing within the park is sinking and now presenting hazards with potential tripping and pooling of water in unsuitable spots, both on hardscape and turf. The basketball court and hopscotch/4-square surfacing is also notably cracked, as well. There is an existing shelter at the center of the park, with posts that are in need of repainting. The amount of wood fiber surfacing is currently insufficient, as it doesn't meet an appropriate level to cover all footings (such as the toddler spring riders), leaving many pieces of play equipment exposed (such as the rock climber).

Overall, the playground equipment is in good condition. It is a combined 2-12 apparatus, and the swings are both belt and bucket (one of the buckets is designed as a special model to accompany the child's parent/guardian).

Overall landscaping is minimal, but the new trees are of diverse selection and the park's perimeter is graced with mature trees that align the creeks to the northwest and northeast.

Many existing trees were lost to the Emerald Ash Borer (EAB). A significant reforestation plan is in progress with 50% of the plan complete and the remainder scheduled in the fall of 2018.

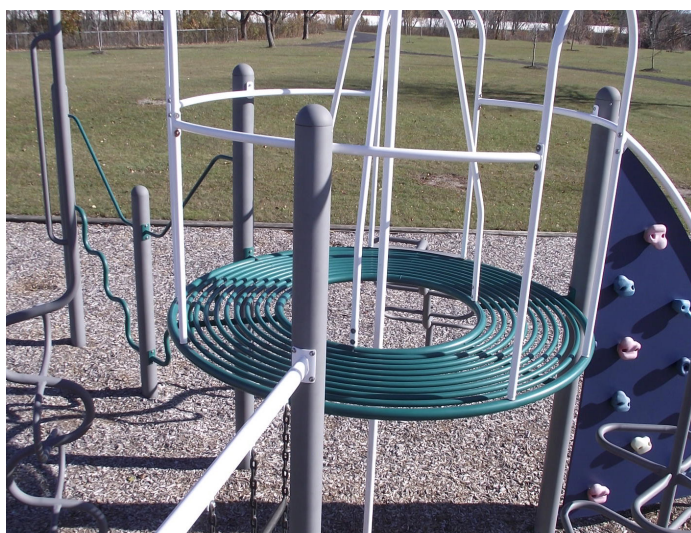
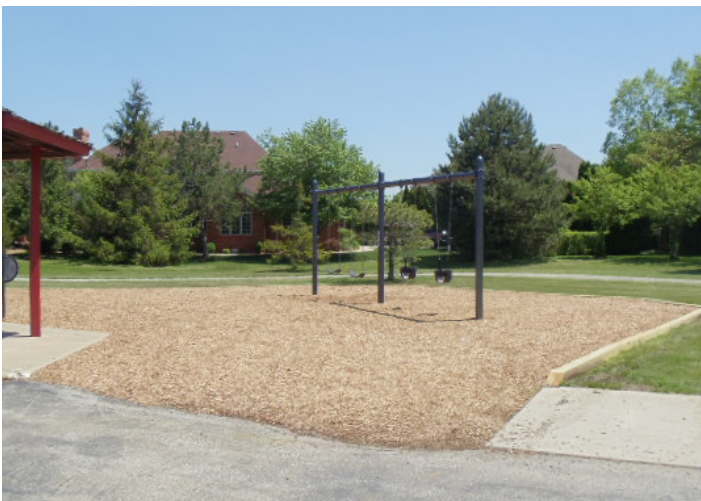
Figure 54: Burlwood Park

The woodchips of the playground are contained by wood timbers. The surface elevation throughout the play area appears to be well below the recommended surface elevation where slide exit chutes and steps/transfer modules meet the surface. These wood timbers have also begun to age and weather. Seating opportunities for care givers and parents to watch and supervise their children were limited to a picnic table located beneath the existing gazebo/shelter. Since the initial inventory, additional benches have been installed at the park.

The gazebo/shelter is a small prefabricated structure with cedar shingles that can only accommodate one picnic table. The structure is centrally located within the park on a concrete pad which appears to be in good condition. However, the asphalt path leading to it does not meet the top of the concrete pavement flush, creating a trip hazard for park patrons. The shelter structure has begun to age, weather, and deteriorate from 19 years of exposure to the exterior elements. The drinking fountain is an older version of Murdock Fountains. While still operable, the drinking fountain is not ADA accessible and the color of the fountain's exterior steel frame has faded lacking curb appeal.

Entrance into the park is flanked by a blue 30 gallon drum used as a refuse container and a 4x4 wood post

with signage identifying park information and rules. Although serving a vital role to park patrons, the sign and litter are both unattractive and non-welcoming.

The asphalt path loops the entire park connecting to the existing concrete walk within the parkway. The asphalt surface appears to be level and free of major cracking, however, the surface needs seal coating to provide a fresh look to the park. Along the path leading to the gazebo/shelter are two independent bike racks surface mounted on a concrete pad. The bike racks appear to be in good condition.

The park site consists of minimal landscaping. The site appears to be very open and void of many shade opportunities. The few trees which are located within the park overall are in good to fair condition. Overall maintenance is very good. The turf is in fair condition.

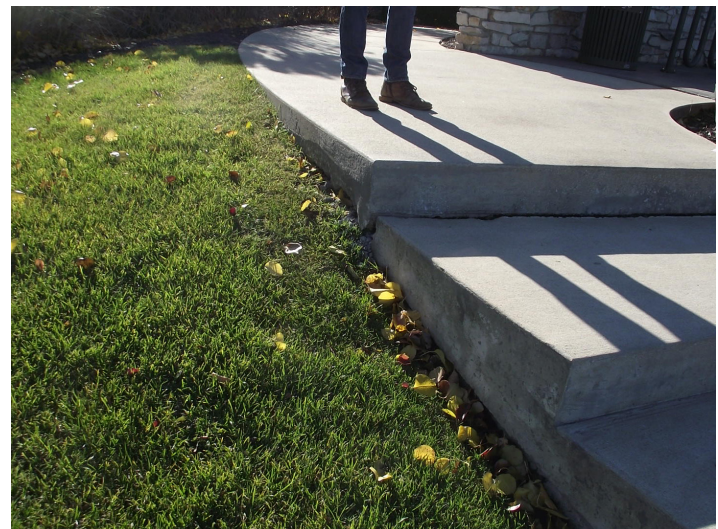
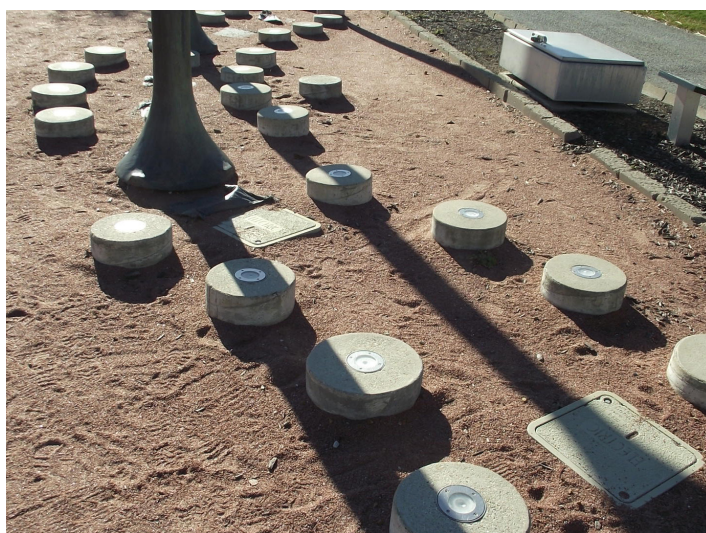
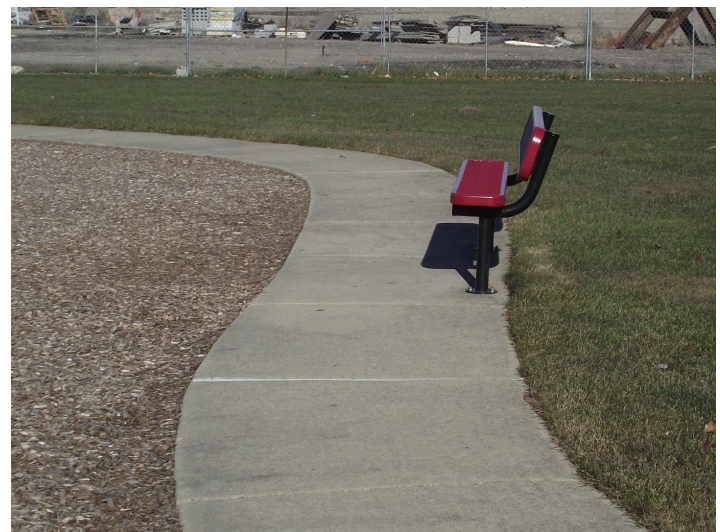
Figure 55: Centennial Park

The catch-and-release fishing area consists of pressure-treated timber boardwalk constructed in an oval fashion bordered by a precast limestone seat wall. The timber decking appears to be in good condition. The seat wall also functions as a retaining wall to a sloped native conservation planting area which surrounds the boardwalk. The natural conservation area appears to consist of hearty natives and other vegetation indigenous to the area. This native planting area appears to be overgrown and in need of management for aesthetic

The creative play area is in fair to good condition but nearing the end of its useful life expectancy. There are two composite apparatus structures with multi-level decks; one for primary age users 2-5 and another for school-age users 5-12. The area also consists of a pyramid net climber with rock climbing wall and a three-bay swing set. The independent swing set includes 4 belts and 1 bucket seat – at the time of the site tour, one bucket seat was missing. Both of the composite apparatus structures, the pyramid net climber and the independent swingset is in good condition. There is some fading of play panels and slides, but no peeling of the finishes was apparent. The playground's accessible surface material is wood fiber mulch (woodchips). The wood chips are at an appropriate level and free of weeds. The play area is bordered by concrete containment curb/walk. The concrete around the play area is in good condition. There were minimal seating and shade opportunities surrounding the creative play area.

The reservable shelters and washroom building are in good condition. The concrete surface beneath the shelter area appears to be in good condition as well. Other site furnishings consist of picnic tables and litter receptacles. The litter receptacles were white 55 gallon drums and were not consistent with the style of receptacle located

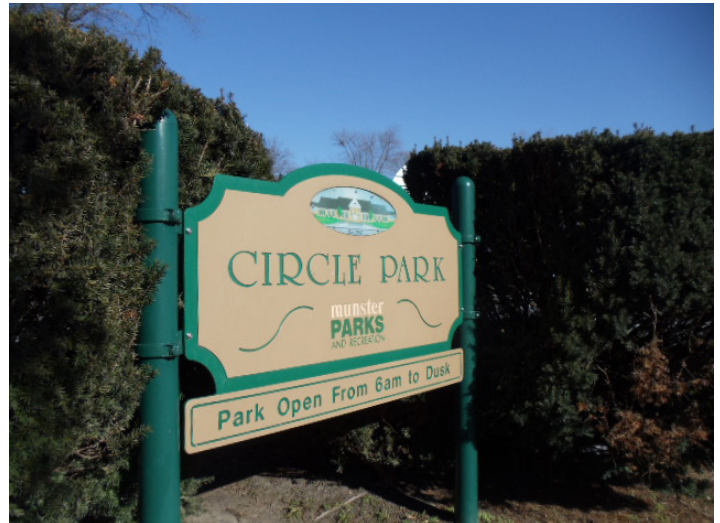
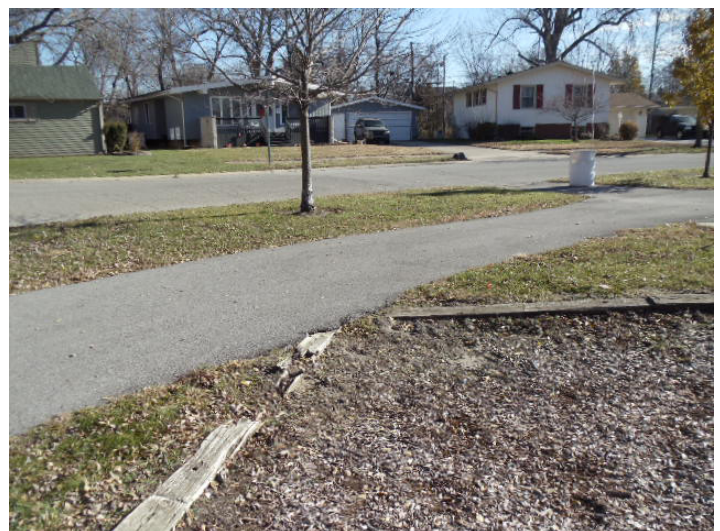
Figure 56: Circle Park

The preteen playground is in fair to good condition. Even though the perimeter path touches the playground at that point, it does not provide an accessible connection to the play surface at that point. The play area is bordered by timbers on all sides except adjacent to the basketball court on the south side.

Perimeter timber curbing is broken in some areas and should be inspected/replaced. Accessible routes to play surface when replacing containment should be considered.

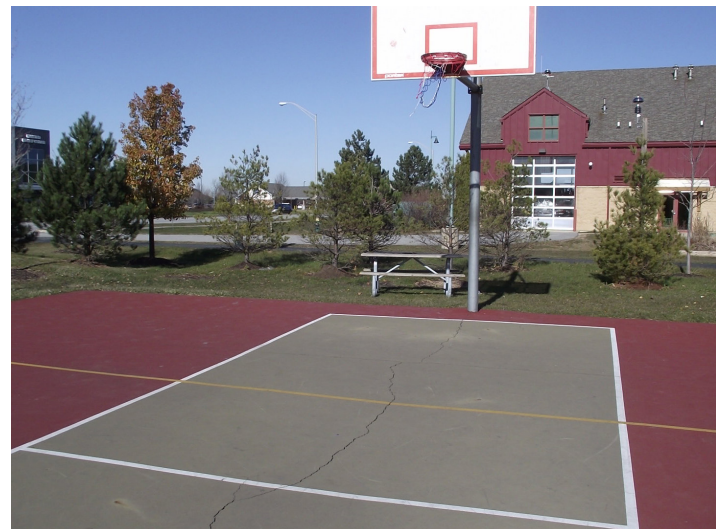
Figure 57: Cobblestones Park

To the north of the parking lot is a hardscape court, combining basketball and volleyball. It currently has notable cracking down the middle. To the east of the parking lot is a softball field with limestone screening surfacing, along with a new and well-structured backstop.

There are two tennis courts to the east of the creative play area. They are below average condition, with significant cracks throughout. The entry to the courts from the gates is a concrete pad. It doesn't connect to any path.

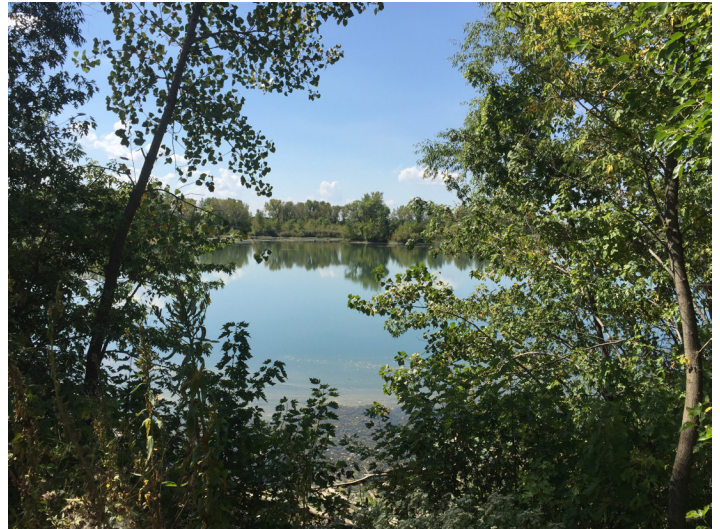
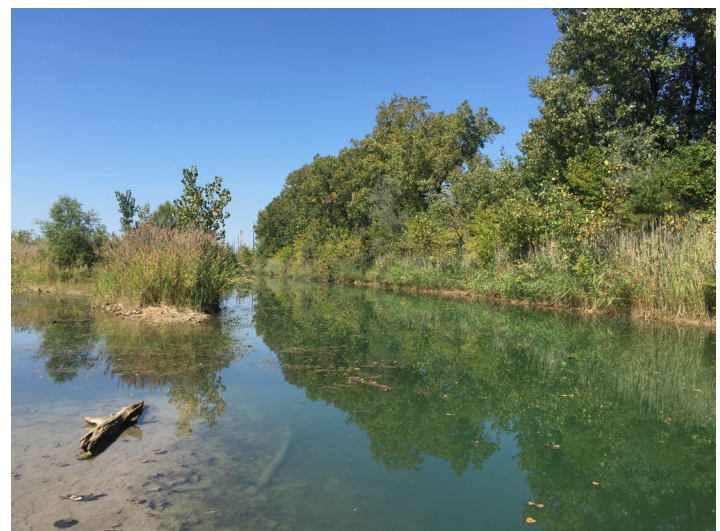
Figure 58: Clayhole Lake Greenspace

The vegetation is dense, and moderately represented with invasive species such as buckthorn and honeysuckle. The quality of the water, at first glance, is moderately low given its murky appearance. Fishing here is not promoted, currently. Neither is swimming, boating, or ice skating.

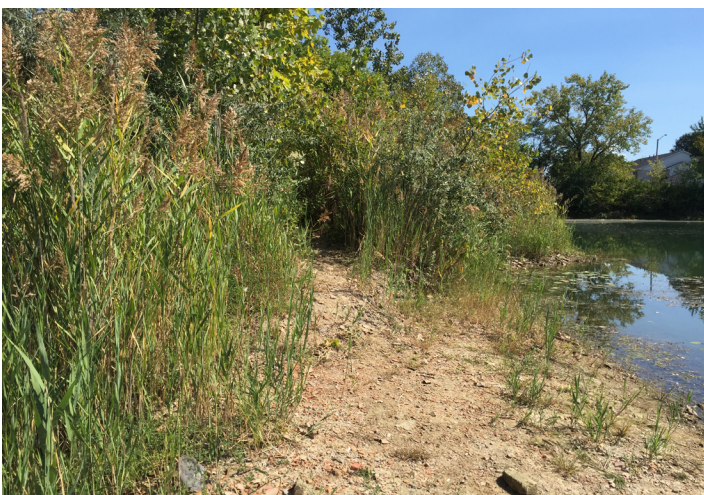
Access into the site is obscure and uninviting. Currently, it is a narrow path coming from the northeast end of the lake near one of the newer residential developments on Tuckahoe Place. There is a berm that runs along Tuckahoe Place, discouraging use of the nearby lake; no formal entrance exists currently. Situated just south of the existing railroad tracks, it is limited in its access to residents north of the site.

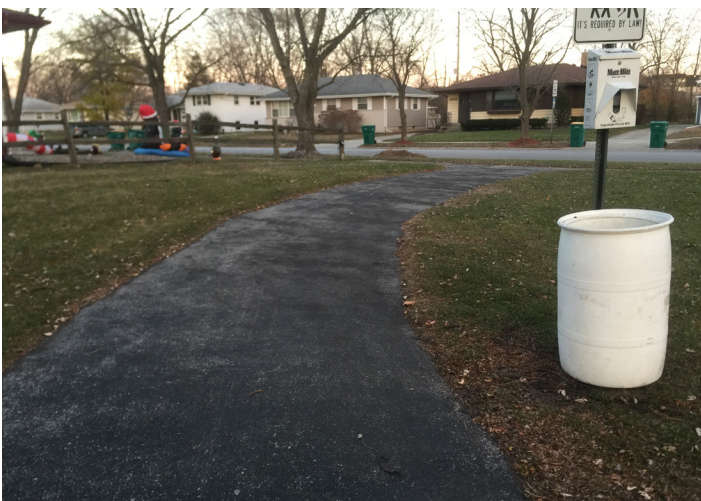
Figure 60: Evergreen Park

The south end of the park is predominantly open space with lawn and widely spaced trees. There are no furnishings located there, except for 1 picnic table. Toward the north end of the park there was a half-sized basketball court that has been converted to other court games including hopscotch-foursquare / tic-tac-toe play court. The hardscape surface is in poor condition in areas and would most likely need resurfacing in its entirety.

There is an asphalt path that crosses the park from Manor Avenue’s sidewalk to the walk on Timrick Drive. Adjacent to this walk there is a concrete pad and bike rack toward the center of the site. The simple u-shaped bike racks are in fair condition, with slightly rusty metal. At the east end of the asphalt path is a dog waste station and a plastic tub in good condition. The use of the plastic tub is undetermined.

The passive areas on the site have a generous amount of open space with lawn and some mature trees. There is plenty of shade for the park overall and a healthy mix of tree species throughout. The ornamental landscaping of ornamental trees, shrubs and perennials is lacking however. The park looks like it is maintained fairly well and has fair curb appeal to the neighborhood. Overall, this park is not inviting and inspiring.

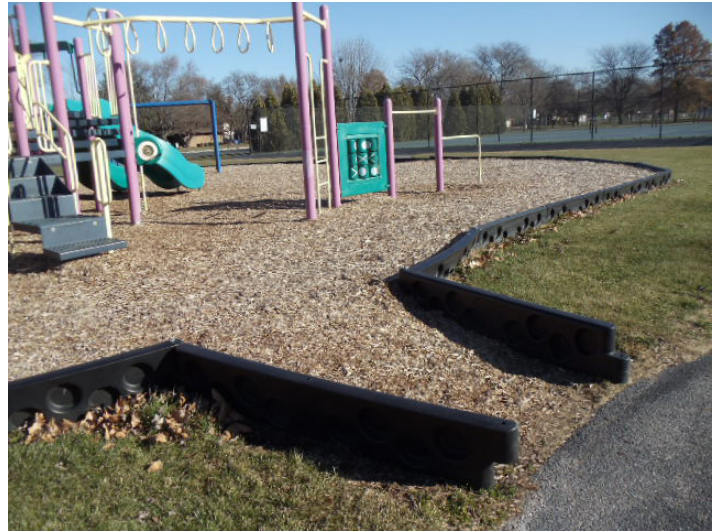
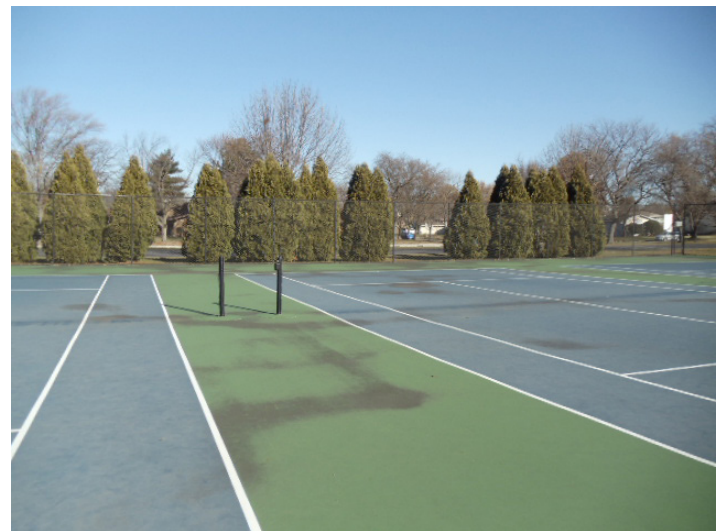
Figure 61: F.H. Hammond Park

F. H. Hammond features supplemental parking off-street along Oriole Drive. A running track surrounds an active court area comprised of tennis, volleyball, and pickleball. The infield of the track also includes an active playground area for pre-teens. The playground area loose fiber fill surface is contained by above ground plastic curbing. The curb breaks to permit access from the adjacent asphalt pathway. The raised curb creates issues with maintenance of adjacent turf. The access point may not meet ADA access requirements. The play apparatus appears to be in fair condition, however, it is faded and worn. Some components are peeling paint and rusting, and it may be reaching its useful-life.

The tennis court surfaces are in poor to fair condition. Surface shows evidence of standing water and mildew. Vegetation is planted as backdrops on the north and south end of the courts. The plantings

along the south side are too close to the surface and can drop litter and debris onto the court surface.

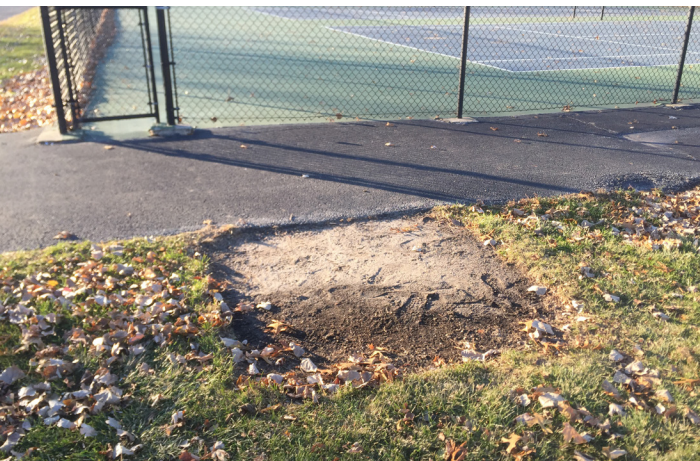
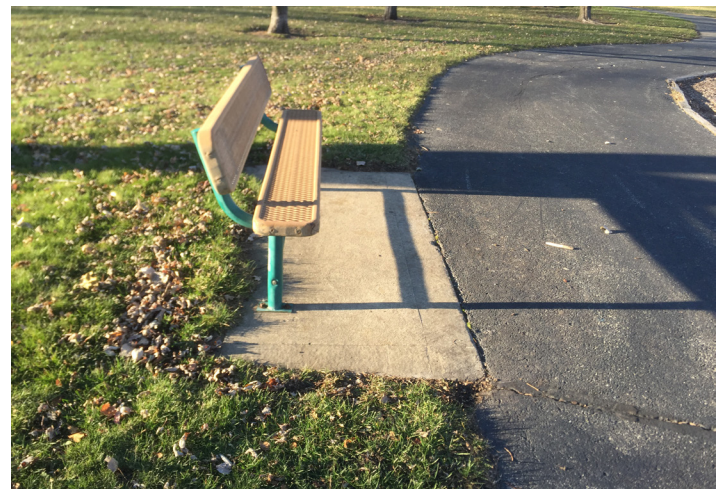
Figure 62: Grove Park

The park's sign is located on the west side of the park along Tapper Avenue and appears to be newer and in good condition. There is an off street parking lot for the park located on Ridgeway Avenue with 21 spaces. There are no accessible ADA spaces and none of these spaces have backstops or curbing. There are concrete sidewalks along Tapper Avenue that connect to asphalt paving that runs adjacent to the play area. The walks are accessible and are in good condition. Another asphalt walk connects the Ridgeway Avenue sidewalk with the full basketball court. There are two hoops in good shape; no fencing around the court, and no lights. To the south of the court is another hardscape area with an undetermined purpose. It may have been a former court, but there is no striping on it to designate an obvious purpose. There is a "mutt mitt" dog waste station in between the parking and this court as well as plastic tub trash receptacle in good condition.

There are 3 tennis courts surrounded with vinyl chain-link fencing all around. The courts are in good condition with some ponding marks. To the north of the tennis courts is the softball field. There is a ballfield galvanized backstop (some rust and wear) with 2 spectator bleachers (metal, 15 x 5 rows with no fence but backed by wood timbers). The infield is limestone screening. There are neither field lights nor dugouts. To the east of the ballfield is a large soccer field (they may double as a football field) oriented north-south. One soccer goal was present.

To the west of the ballfield is a non ADA compliant drinking fountain and concrete pad for 3 u-shaped metal bike racks in good condition. The asphalt path connects these elements to the reservable open shelter structure

(capacity ~ 40 persons with picnic tables). Adjacent to the shelter is the park sign with minimal landscaping. North of the sign is a memorial to Corporal Robert Grove and flagpole, which surrounded by pavers.

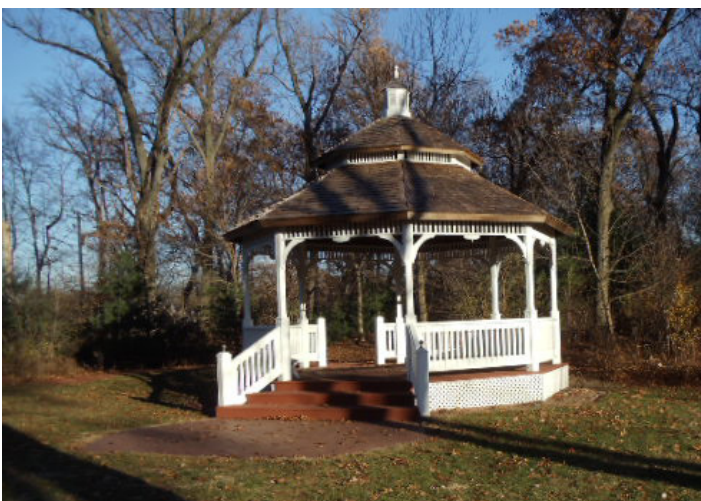
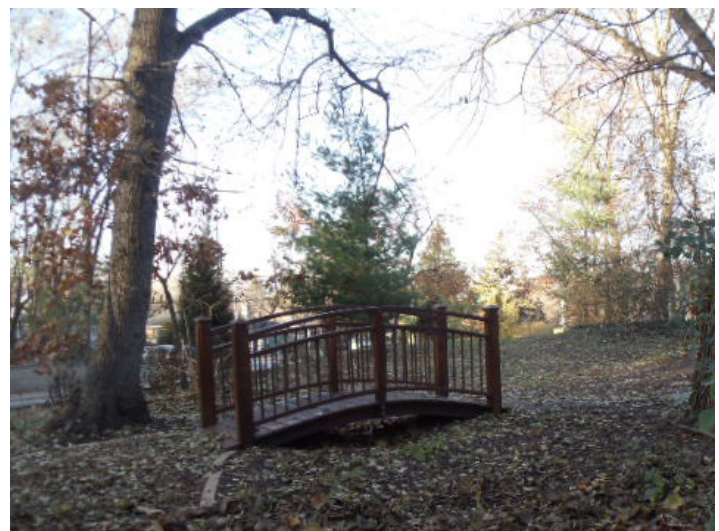
Figure 63: Heritage Park

The MHS offers the site for rentals such as weddings, as well as conducts several public service events throughout the year. Access to the site is via a brick paved drive from Columbia Avenue. The access is narrow and visibility into and out of the site is difficult. Site capacity is severely restricted by parking.

The site is home to a gazebo that is used for wedding ceremonies and bridal party photography. The gazebo is accessed via a nicely crafted ramp, but may not meet ADA accessibility requirements given it is across the

inaccessible lawn. The back of the house is cluttered with “modern maintenance appurtenances”.

Southwest of the house is a meditation walkway with benches and statuary along the path. The wooded path is in reasonable condition but likely not considered as ADA accessible due to boulders restricting access to the path, path materials, and the slope/gradient.

A historic windmill is located on the site southeast of

the house. The windmill was originally manufactured in Colorado, was put in service in Jasper County Indiana, and later donated to the Munster Parks and Recreation Department. The windmill was relocated to the present site in 2001.

Parking on-site is limited, with ingress/egress difficult due to size of parking surface. Vehicles have difficulty exiting once in the site. Additional parking is available through an agreement with the adjacent Church.

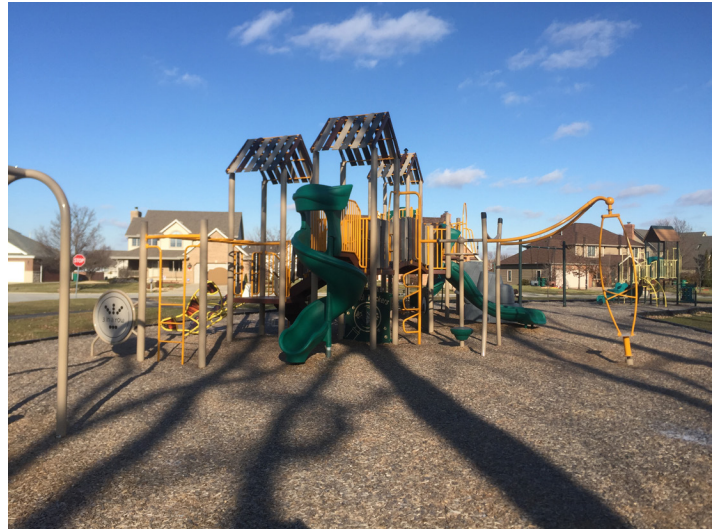
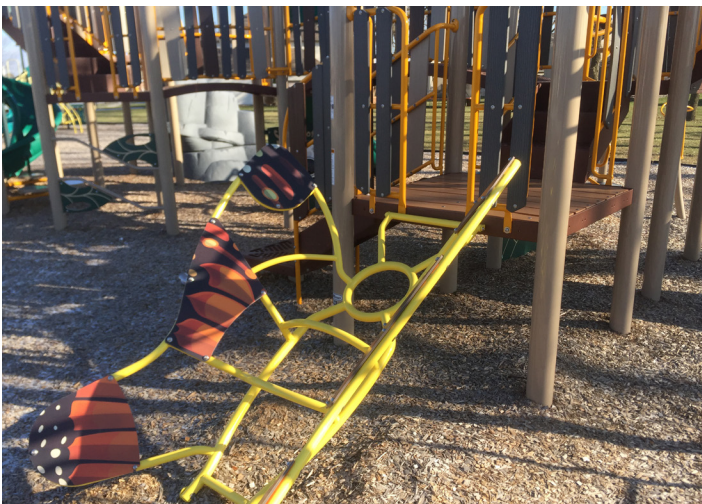
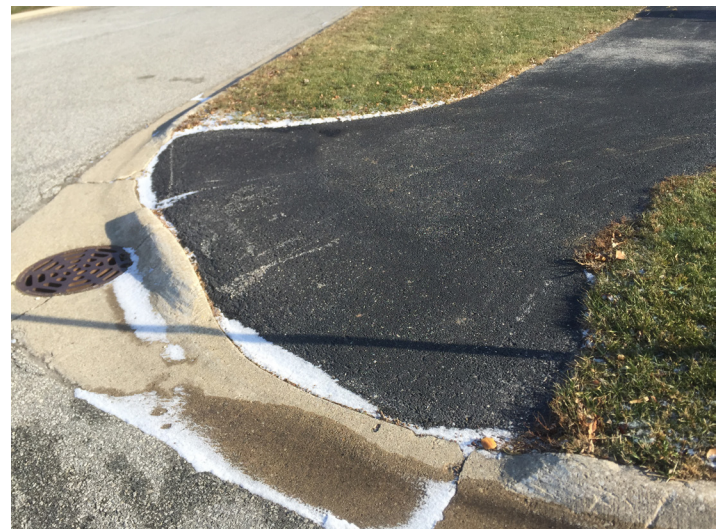
Figure 64: John Friend Park

This park features new play equipment, EWF as surfacing, a picnic bench, a park bench, a bike rack, a waste bin, two belt swings, and two separate bucket swings. There are a row of maturing trees to the south edge of the park, with an effect of partial screening the homes to the south. The infrastructure was such that the path is of asphalt, the play surfacing is engineered wood fiber, and the curbing of the play area is plastic, and the entry into the play area is ADA compliant.

Certain elements to the park require adjustment and/or upgrade. During the site visit, the picnic bench was situated in the middle of an entry path. The waste bin is outdated, as is the park bench in the play area. With the exception of the trees to the south, there is a lack of landscaping throughout the site.

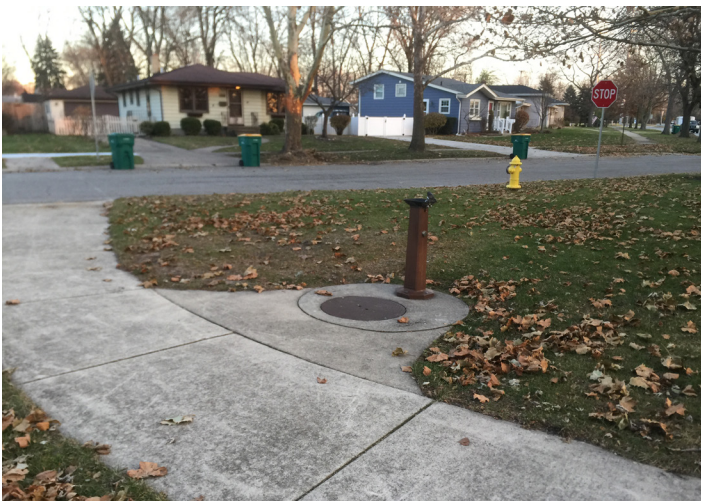
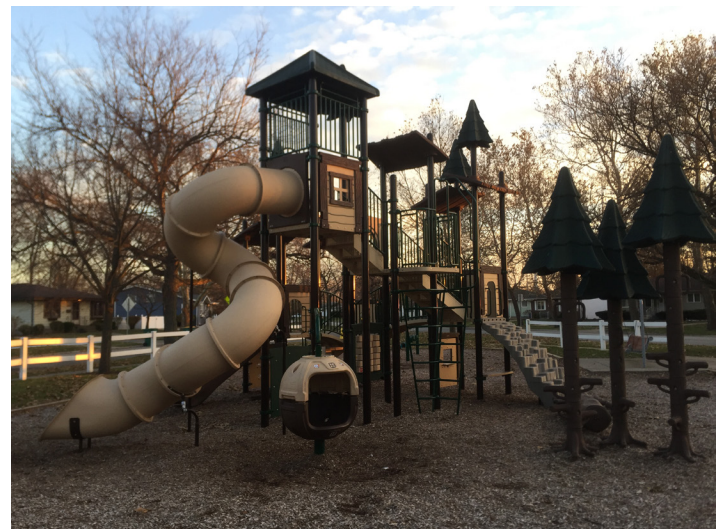
Figure 65: Kiwanis Park

The park’s sign is at the southern point of the site, and appears to be newer and in good condition. There is no parking lot for the park; however there is plenty of on-street parking on both Timrick Drive and Meadow Lane. There are concrete sidewalks along both streets that meet at the southern end of the site and split to allow crossing for both streets. The walks are accessible and are in good condition. A concrete pad and bike rack are located in the middle of the site on the Meadow Lane side. The bike rack is a very simple u-shape metal rack in fair condition with some rust. A trash receptacle is also located on this pad. It is an inexpensive plastic tub in good condition.

The play area equipment is for ages 5-12, looks relatively new (replaced in 2017) and is in very good condition. It is Playcraft Systems. It has integrated pieces and is not accessible. The surface of the play area

is EWF with a wood play area border. Next to the play equipment are swings: 2 buckets and 2 belts and are in good condition. White plastic composite split-rail fence on both sides of the play area has mold stains and is not in great condition. The fencing effectively defines two spaces. A swing bench located on a concrete pad adjacent to the play area is in fair condition. The swing provides great sight lines of the play area. A drinking fountain is located where both sidewalks terminate and is in good physical condition but is not ADA accessible. Two picnic tables located in the lawn areas adjacent to the play area are also in good condition.

The passive area to the north end has a generous amount of open space with lawn and some mature trees. There is plenty of shade for the park overall and a

healthy mix of tree species throughout. The ornamental landscaping is lacking however, and there are no planting beds of shrubs, perennials or groundcovers on the site. The park looks like it is maintained fairly well and has very nice curb appeal to the neighborhood.

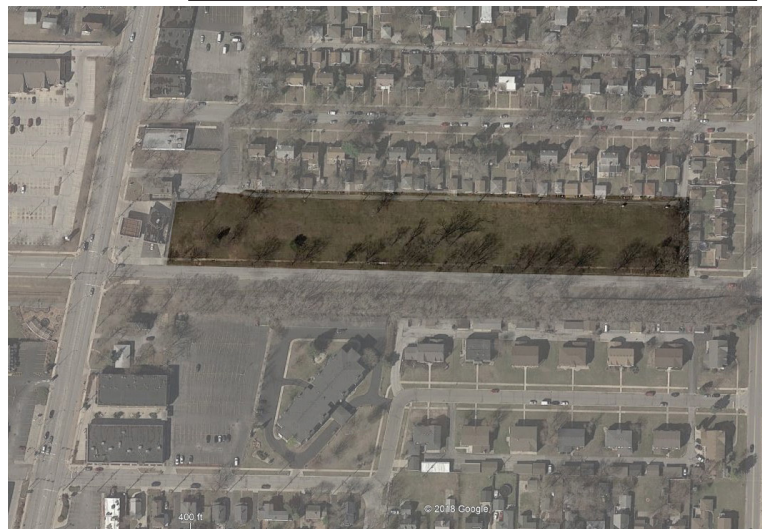
Figure 67: Monon Trailhead

The Monon Trail Head and Fountain is located on the southeast corner of Ridge Road and Manor Avenue. The site features an overhead shade trellis, fountain, drinking fountain, memorial brick plaza. It serves as a trail head for the Monon Trail which is a former railroad right-of-way. The trail is part of the northwest Indiana regional trail network currently. In the future, it will connect to a trail network in Illinois and continue south to a spur of the Pennsy Path and the Burnham Greenway. The trail would parallel the proposed right-of-way of the West Lake Line of the NICTD South Shore Line extension toward Lowell, Indiana.

The site is in excellent condition and sets the standard for the Munster Parks and Recreation Department's site furnishing. The site furnishings are in good condition, the fountain is the centerpiece of the trailhead. The site is ADA accessible and provides ADA accessible drinking fountain. The drinking fountain color is inconsistent with other site furnishings.

Bicycle racks similar to other racks within the park system, but inconsistent with site furnishings at this site.

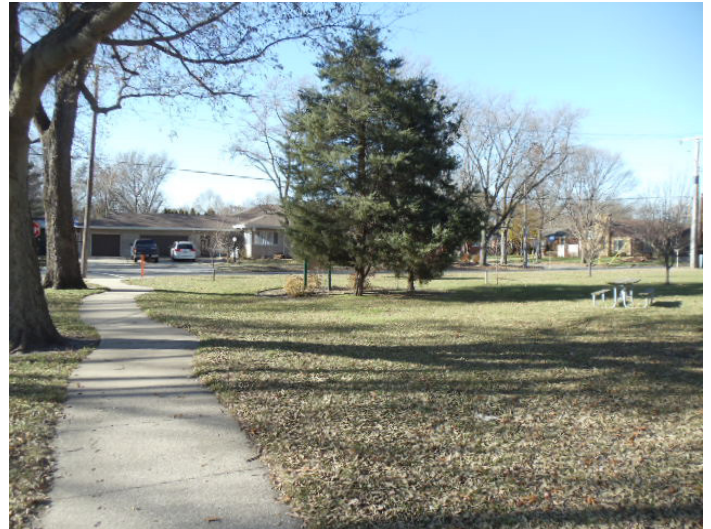
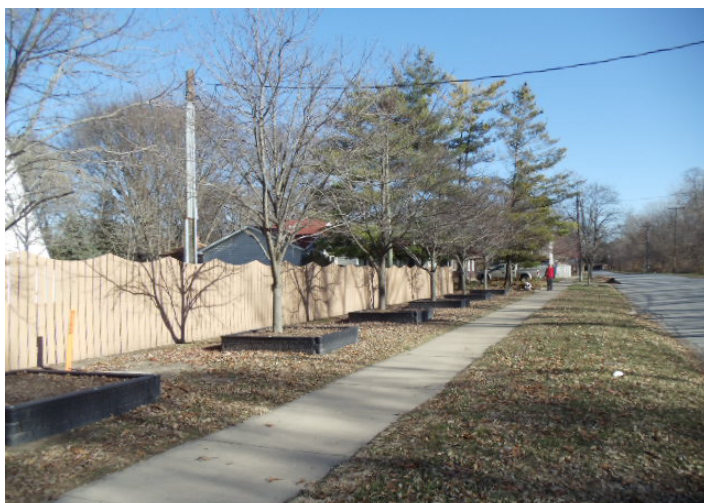
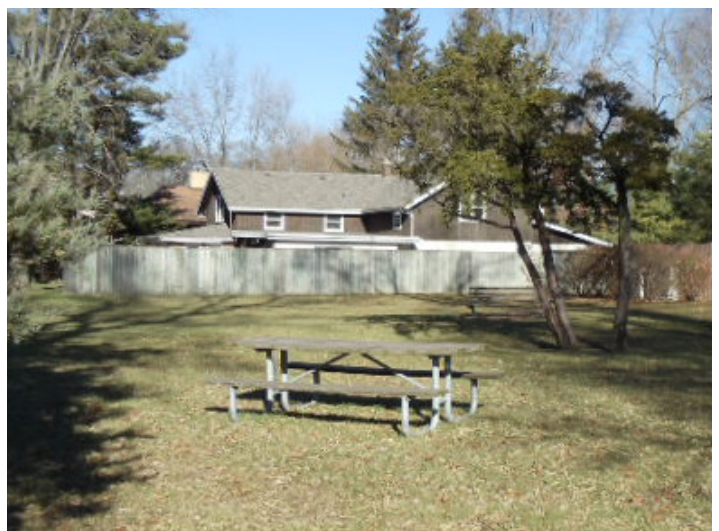
Figure 68: Orchard Park

The site has scattered benches and picnic tables that are in various states of deterioration. The benches are distributed throughout the lawn areas which makes them not ADA accessible. Their locations also complicates maintenance activities as mowing and trimming must occur around the bench supports. The site also has a bike rack along Fisher Street.

There is an existing bocce ball court on the east side of the site that has been abandoned. The site does not appear to be very heavily used as there is little or no signs of wear under the existing benches and tables.

Several newly planted trees have memorial plaques associated with them.

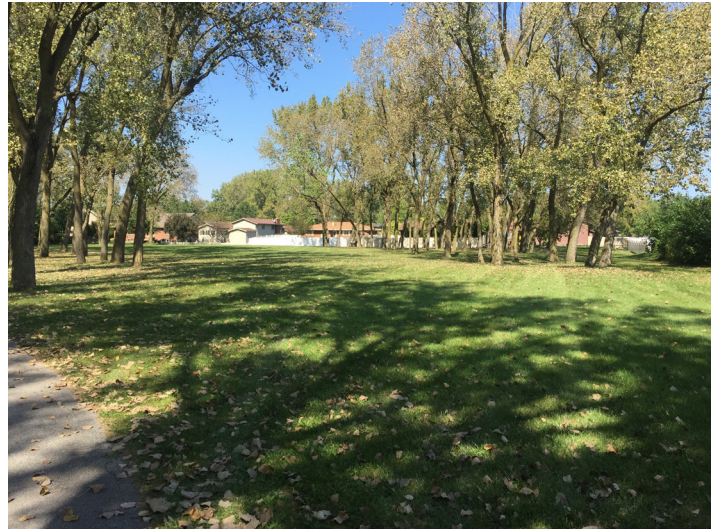
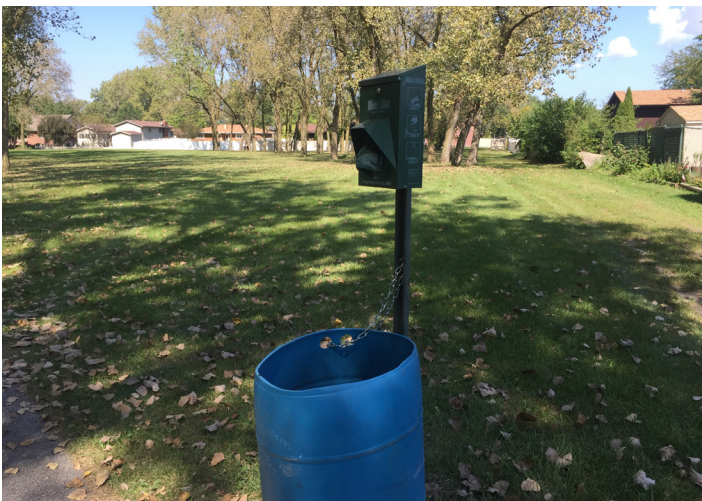
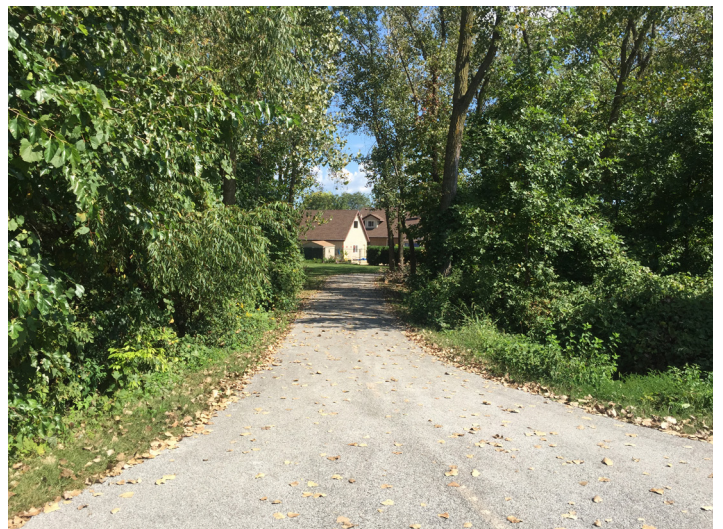
Figure 69: Redbud Open Space

This greenspace offers exclusively well-shaded open play. However, the location itself serves as a gateway into the Penny Path and Centennial Park for residents to its east.

There is also a waste disposal bin and a bag dispenser for walker's with dogs. The path is in good condition. There are many opportunities to expand on the services this park can offer, given its size and open areas.

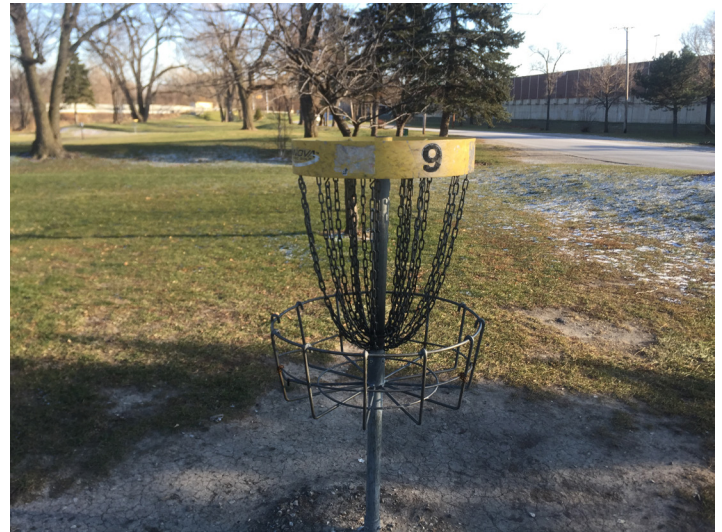
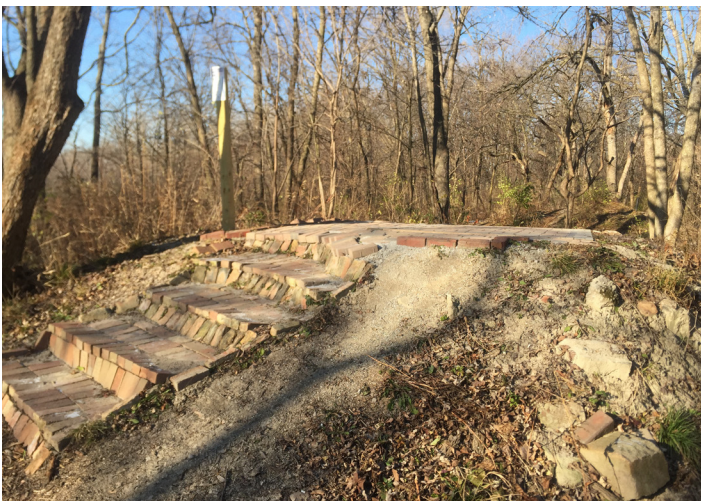
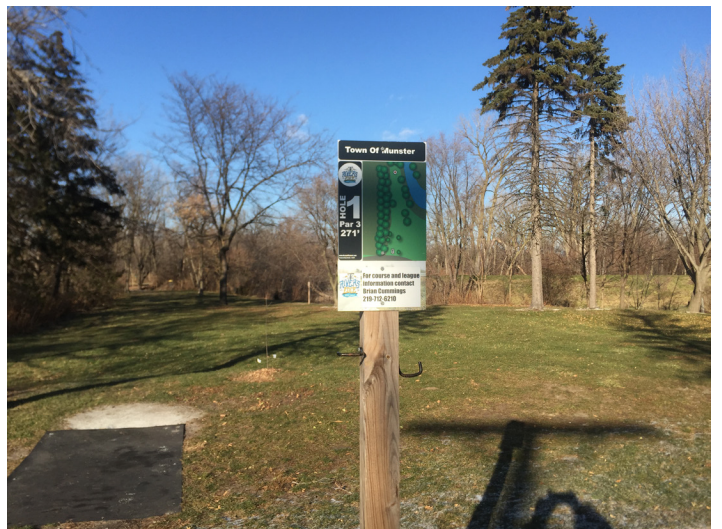
Figure 70: River's Edge Disc Golf

River's Edge Disc Golf Park is a 4.1 acre wooded park located at 1 River Drive along the Little Calumet River just west of Homan Avenue and north of the 94/80 Tollway. The park features a disc golf course and open space.

There is a standard park sign at the Homan Avenue corner that identifies the park site. The park contains many mature trees and a naturalized, if a bit overgrown, shoreline. There is another wood sign and some off street gravel parking at the west end of the park site along with a picnic table and waste receptacle. This location features hole #1 of the disc golf course. The tee boxes feature rubber mats to reduce wear, while the disc hole stands are simply set in the turf or landscape. The course meanders north into a more wooded and natural section of the park where it looks as if some additional holes have been added by residents that are not part of the official course and may not all be on park property. The sign in this location has been modified to note hole 2 "a, b, c, and d" and hole 3. This area has some interesting brick and block and wood patio and seating elements and a lot of grade change leading back into a more wooded landscape. The course then doubles back out along the river to

the far east end of the site and then loops back towards the west end with hole #9 as the final hole back at the southwest corner of the site. The site slopes down from the road to the river so that the course has quite a bit of grade change while maintaining open view sheds.

The park site is across the road from a large barrier wall to the 94/88 tollway and the highway noise is noticeable and constant. Despite this, the site has a very natural character. There are no other specific programmed recreational uses.

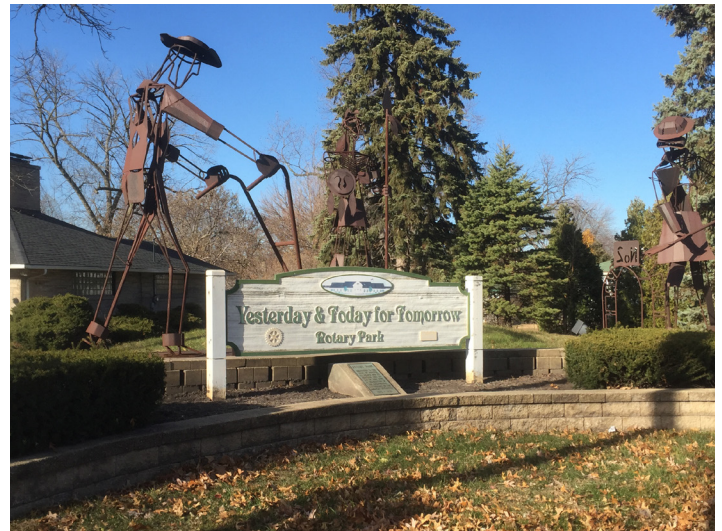
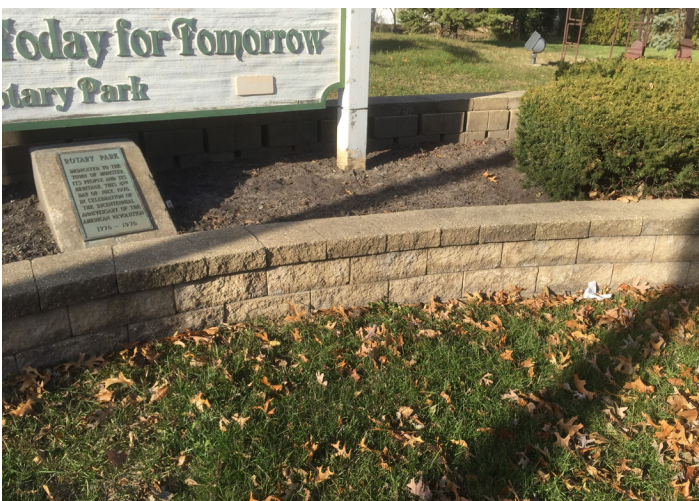
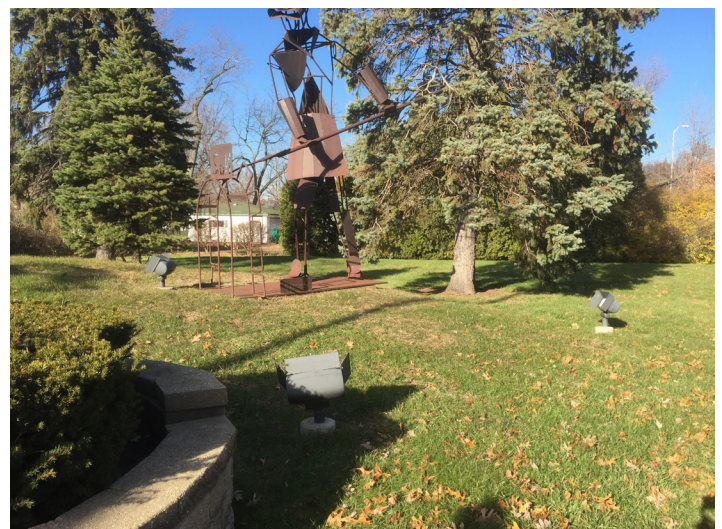
Figure 71: Rotary Park

The park's sign is located in the center of the park in a raised landscape bed. The retaining wall is a segmented block wall in varying heights. The sign is roughly 30 years old and is chipping. It is scheduled for replacement. There is a small plaque in front of the sign commemorating the bicentennial.

The park is predominantly green space of lawn with a few trees and 3 large metal sculptures. The sculptures are approximately 12-14' tall and are in good condition. There are light fixtures that uplight the sculptures and trees. A paver plaza in front of the Rotary Park (approx. 830 sq. ft.) leads up to the corner where the 2 sidewalks along Ridge and Columbia meet. There is a crosswalk signal there and the curbs are accessible.

The park has good curb appeal and appears to be well maintained. The landscape in the raised bed would benefit from enhancement with more attractive and diverse species.

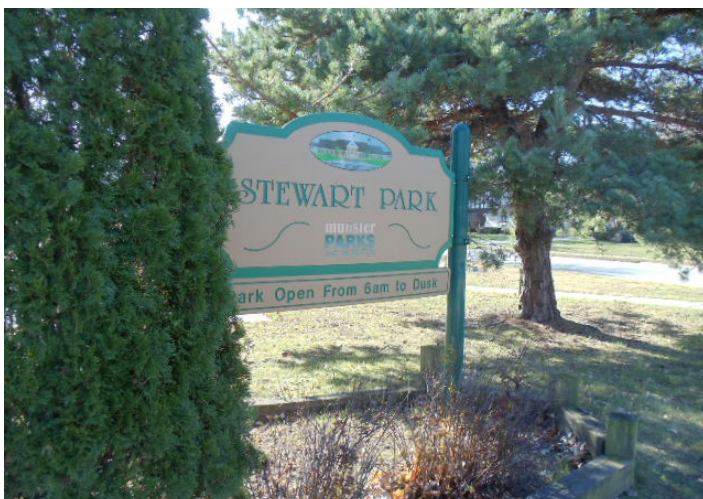
Figure 72: Stewart Park

The parking lot is accessed from White Oak Avenue via curb cuts in the middle of the lot and at the south end of the lot. It appears ingress and egress geometry is inadequate for the turning movements of entering and exiting vehicles. Islands are rutted and damaged by vehicles. The north end of parking lot is a dead end. If no spaces are available, turning around is difficult and potentially causes traffic congestion and conflicts. The parking lot is in need of sealcoating and striping. Parking stalls are delineated by wheel stops which could be damaged or displaced during plowing and winter maintenance.

Soccer goals are stored along tree line near the creek. According to the Indiana Floodplain Information Portal, Stewart Park is not within the floodplain of the adjacent Hart Ditch. The floodplain is restricted to the stream channel and adjacent banks. Existing trees show damage from string trimmers. Additionally, several trees had guy wires and were staked.

Site furnishings do not match other parks. The playground was replaced in 2018. Play surface containment is black plastic ties that restrict access into play area. The containment ties add to trimming times and maintenance efforts. There appears to be significantly underutilized play surface areas that increase maintenance costs/ construction costs with little to no additional play value.
