Chapter 11

Inventory & Assessments

Park Inventory and Assessments

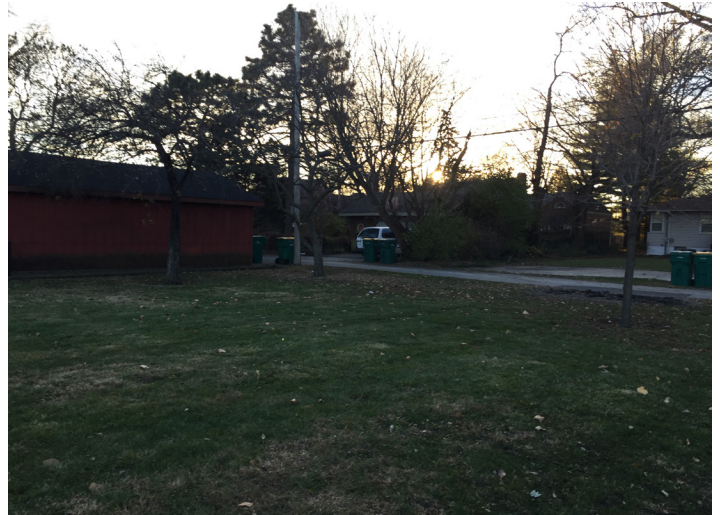
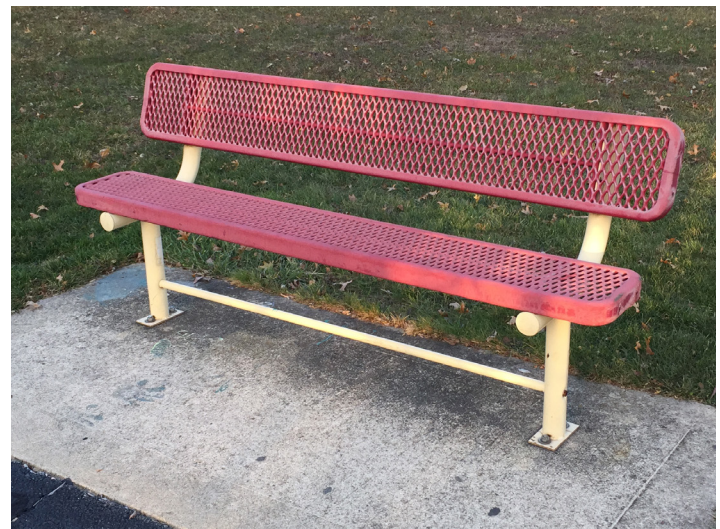
Figure 73: Sunnyside Park

connects to an asphalt path north and south ends, forming a figure 8 through the site around the creative play areas and gazebo. The asphalt looks relatively new and is in good condition. There is one bench (in poor condition) on a concrete slab adjacent to the path. The location of the south connecting path should be relocated to align with the cross-walk at Hohman Avenue.

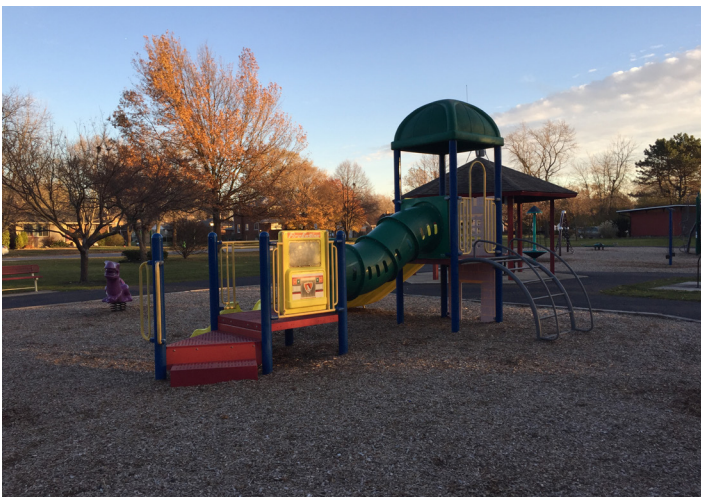
The large play area has a 5-12 integrated play apparatus, a swing set with 2 belt seats, a net climbing structure and other play features sporadically located on EWF (Engineered Wood Fiber) surfacing with wood borders. The equipment is in good condition. The play area is not accessible nor shaded.

the north and south play areas on a concrete pad and is in good condition. It has a 20 person capacity, with a picnic table underneath the shelter which would be inadequate for 20 people. To the west of the shelter is a concrete pad with 2 u-shaped metal bike racks and a plastic trash receptacle; all in good condition. West of the bike racks is a standard Munster drinking fountain on a small concrete pad which is not ADA accessible.

To the north of the shelter is the smaller play area for ages 2-5. There is 1 integrated play apparatus, 1 swing set with 2 bucket seats, and several other play pieces. The surface is EWF as well with wood borders. All the equipment is in good condition. The area is not accessible and there is limited shade at the site.

The passive landscape areas surrounding the play areas between the asphalt path and adjacent alley has a fair amount of open space with lawn and some mature trees. The ornamental landscaping is lacking however, and there are only the couple of ornamental trees adjacent to the park sign. The park is maintained fairly well and adds very nice curb appeal to the neighborhood.

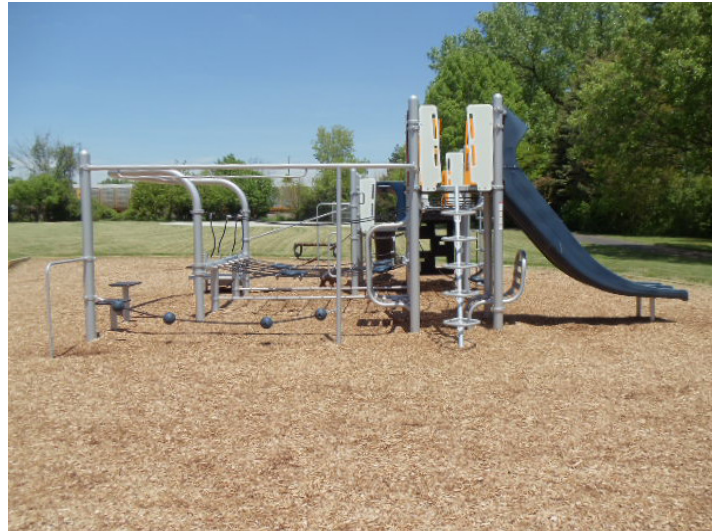
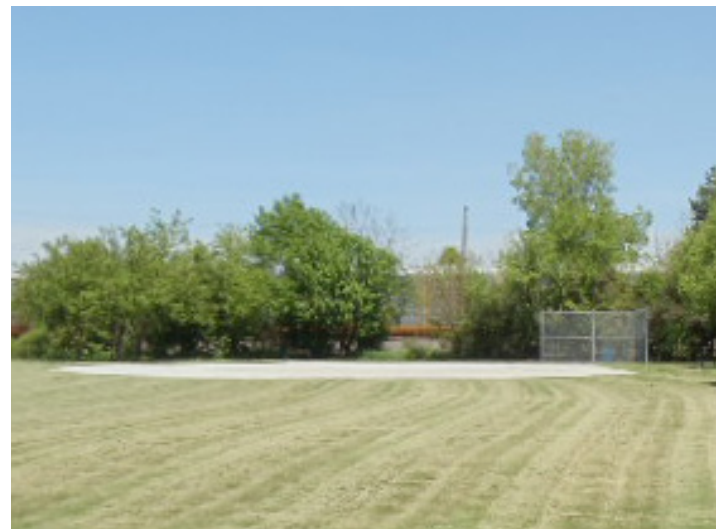
Figure 74: Twin Creek Park

The landscaping has no major issues, although there are several young, dead trees. The concrete within the shelter area is cracking, and on the asphalt path near the backstop, there's a mature tree whose roots have upended the surface. This could cause hazards for people with strollers, wheelchairs, rollerblades, bicycles, or limited mobility.

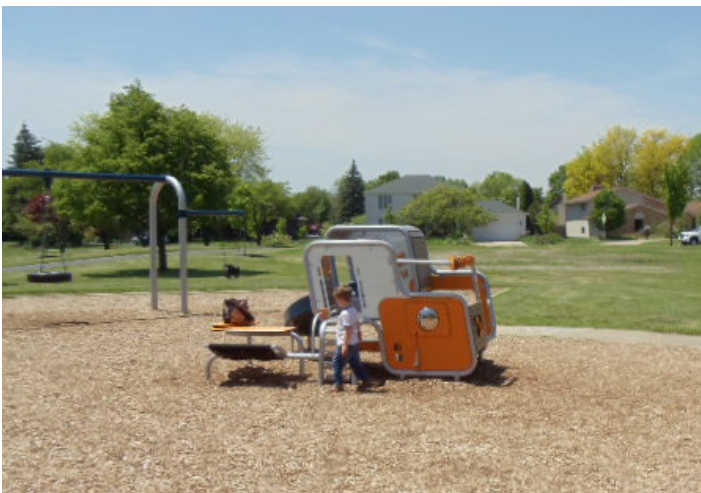
In 2018 the primary play equipment was replaced and the infield for the ballfield was installed as limestone screenings.

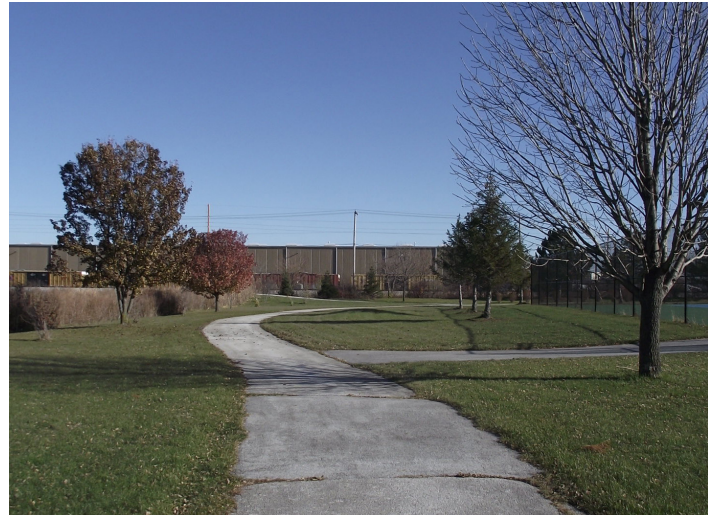
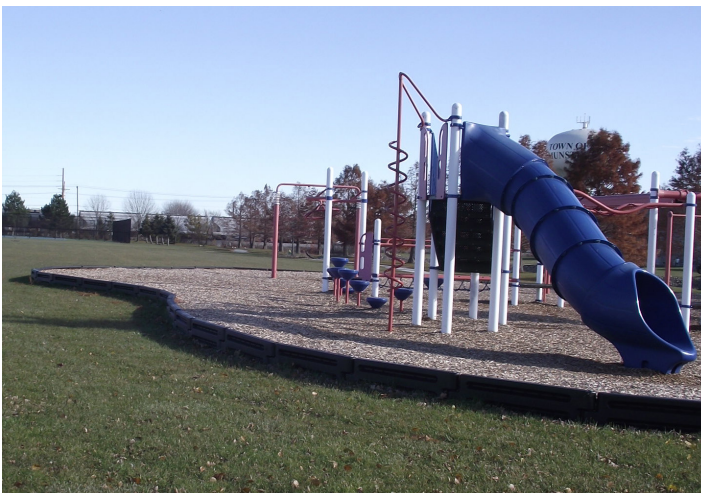
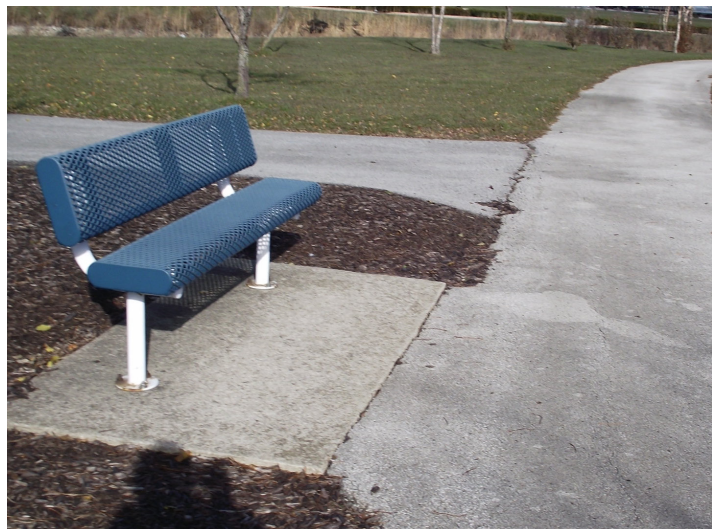
Figure 75: West Lakes Park

The play apparatus is dated, showing signs of red discoloration. It has wood fiber surfacing with plastic

logs serving as the creative play area border. The drinking fountain is in poor shape and not ADA accessible. An existing sound talk tube, directly buried in the ground, has bee's nests within the concave exposed ends. Each swing is isolated from one another in this play area, as well.

The hard court surfacing is in need of repair, particularly on the volleyball and tennis spaces where cracks, holes, and puddling are present. The path network connects users to all parts of the park and is well laid out. Some asphalt deterioration, particularly around the corners of the existing bridges, presents a hazard. Amenities such as benches and bike racks are in suitable condition, although bench pads could be more accommodating to comply with accessibility standards and users with

Landscaping overall is very good, as there is noticeable attention given towards the parking lot planting islands and streambanks. There is minimal screening between the park and the railroad tracks, leaving clear views to the park's eastern boundary. The south end has a narrow east-west oriented detention pond that attracts geese and has rip-rap along the edges.

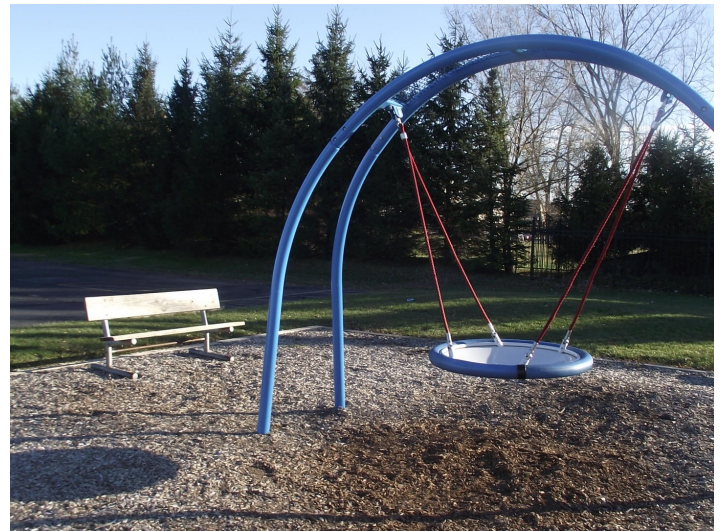
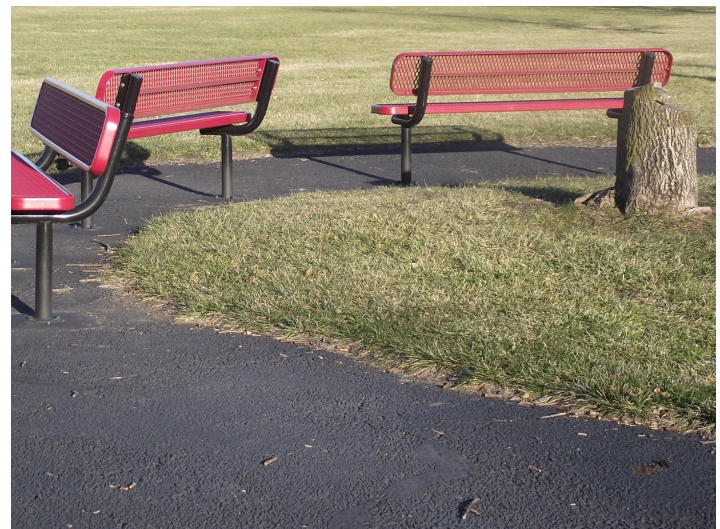
Figure 76: White Oak Park

Landscaping is good quality. Fencing along the southwest corner is unnecessary and unsafe due to spear-like ornamental features along the top margins. It's possible, however, that this fencing is privately owned. The concrete surfacing of the shelter is sunken along the boundary, and it can pose as a tripping hazard. Along the path, there are dead trees in need of replacement within the circle nodes. Waste bins do not meet desired standards, as well. There is safety lighting at this park which requires additional evaluation.

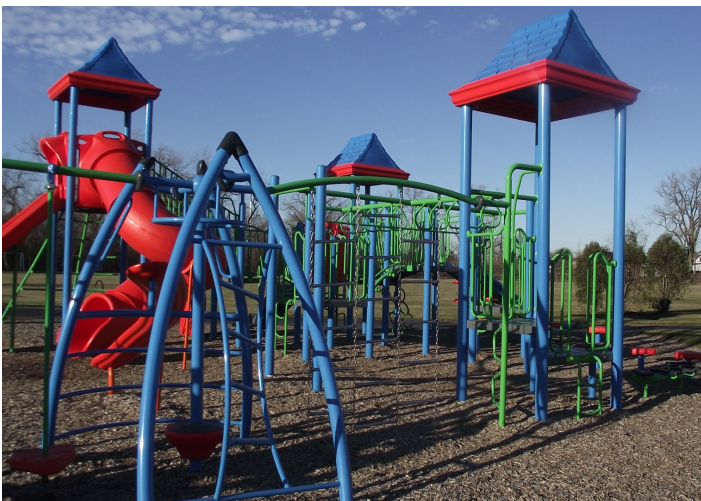
White Oak Park is a 10.4 acre neighborhood park south of 45th street and west of White Oak Avenue. It has an open green space large enough to comfortably fit a soccer field, with a well-conditioned asphalt path around the green space's perimeter.

To the east of the shelter are 3 pickleball courts aligned east-west and paved in orange and blue. The condition of these courts is outstanding, perhaps due in part to the relatively new introduction of pickleball by various parks and recreation departments/agencies. To the east of the pickleball courts is a playground area with an apparatus suitable for the 5-12 age group. With colors matching the pickleball court, this apparatus also happens to be a relatively new in installation. Its condition is excellent- it has a stand-alone infant swing and a bucket swing that allows for the parent/guardian to sit and swing along with the child.

To the east boundary of the park, there is a community of mature trees along the Hart Ditch and a bridge that crosses over the neighboring park, Twin Creek.
